Manhole Inspection Summary

Manhole # S43CC_047MH

Insp Date: **12/19/07 10:14 AM**

Location Address: **1601 e.eager st**

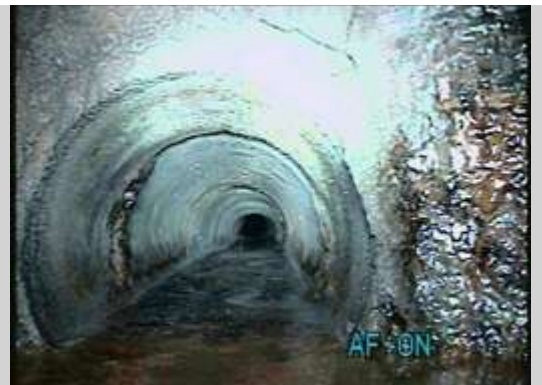
12 O'Clock Outflow

6 in. Circular Gravity Sewer
Pipe Out @ 12 O'Clock

Pipe Material: **Clay** ☐ Pipe Lined

Infiltration: **None** Pipe Seal Cond: **Unknown**
